CyberKey

CyberKey Contact Cleaning Instructions

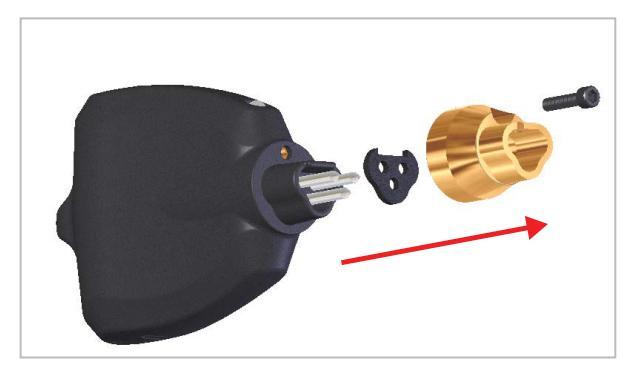
Figure 1: Remove Tip and Insulator from Key

CyberKeys shipped between 1 September 2005 and 7 February 2006 were manufactured with stainless steel contact pins with nickel plating. In moist conditions, current flowing through the contact pins of a CyberKey may cause some oxidation of the nickel plating on the surface of the pins. If the oxidation continues to build, it can interfere with the electrical contact between the CyberKey and CyberLock. When that occurs, the CyberKey may respond slowly or not at all when it contacts the CyberLock. To restore the CyberKey to proper working condition, the oxidation must be removed. To do so, follow these simple steps:

- 1. Gather the following items:
 - A sheet of 400 grit sandpaper
 - A 5/64" hex driver or Allen wrench (using a power driver may damage the CyberKey's plastic case)
- Remove the replaceable brass tip and the insulator from the end of the CyberKey. Be careful not to lose the screw or any of the parts! See Figure 1.
- 3. Lay the sandpaper face up on a fl at surface. Hold the CyberKey perpendicular to the sandpaper and touch the contacts to the surface.
- 4. While applying gentle pressure, pull the contacts over the sandpaper, with the ground contact (the one furthest from the LED) leading the direction of travel. See Figure 2.
